# **TÜV SÜD SCoRE**

## Building sustainability assessment

Building:	VTP Roztoky, Přílepská 1920, Roztoky
Building owner:	VTP Roztoky, a.s., Přílepská 1920, Roztoky
Company:	TÜV SÜD Czech s.r.o., Novodvorská 994/138, Praha 4
Registration number:	05.763.226
Team of experts:	Ing. P. Zinburg, Ph.D., Dr. P. Hlavinková, Ing. P. Marek, Ing. S. Hykyšová, Ing. J. Kulhánek MRICS
Release date:	2012-08-01

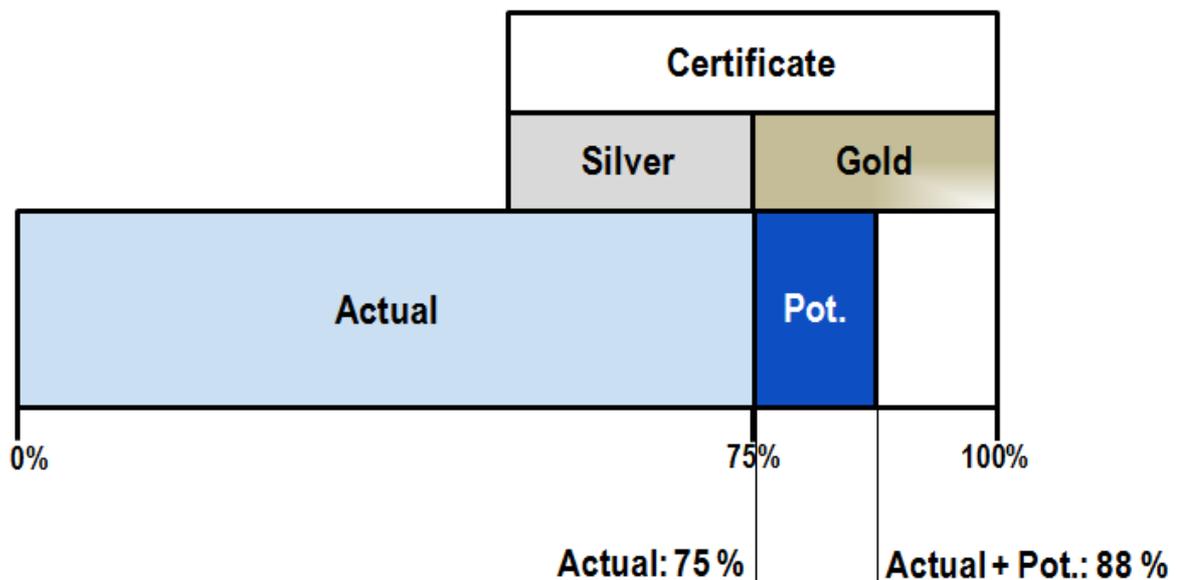
The building VTP Roztoky receives 1 505 points of 2000 possible. With the realization of potential for improvement the building can achieve 1 764 points.

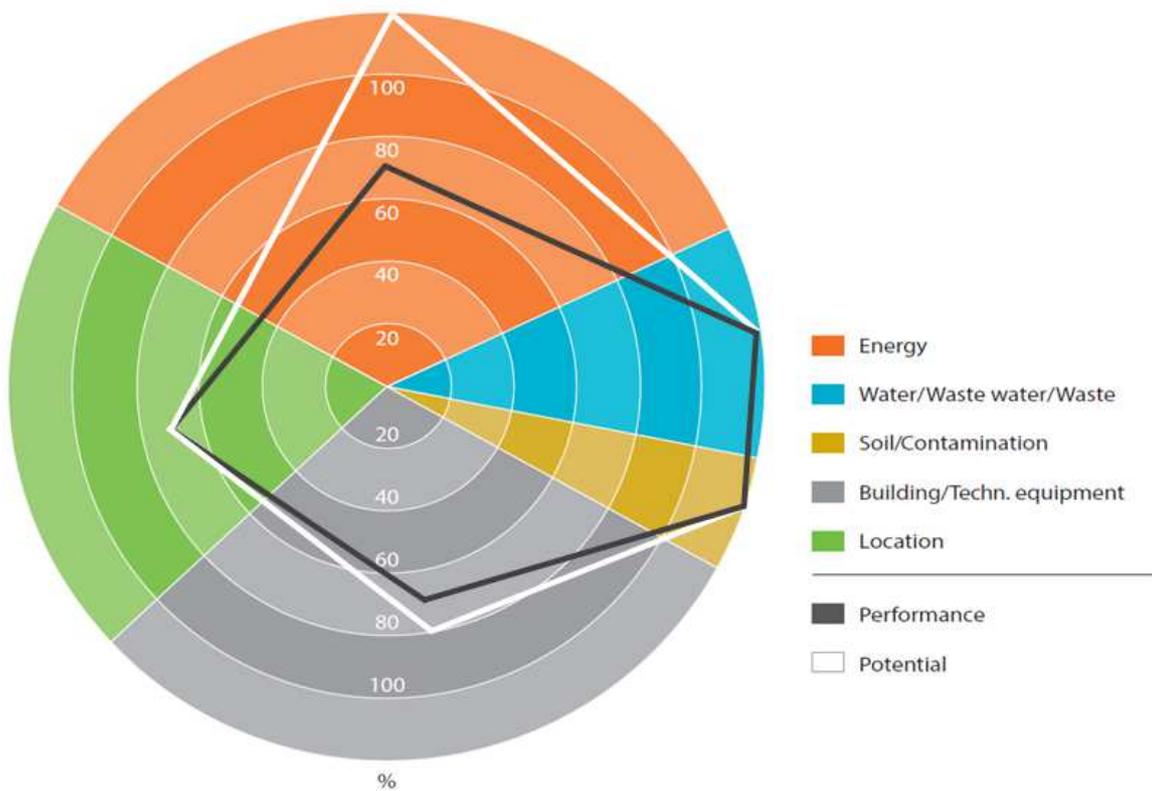
The individual parts of the assessment were evaluated as follows:

No.	Module	Achievable SCoRE	Achieved SCoRE	Possible potential for improvements
1	Energy	700	511	700
2	Water, waste water and waste	200	200	200
3	Soil / Contamination	100	100	100
4	Building	600	414	484
5	Location	400	280	280
<b>Total SCoRE:</b>		<b>2 000</b>	<b>1 505</b>	<b>1 764</b>
